PRIMARY RECORD

Page 1 of 1 *Resource name(s) or number (assigned by recorder) 251 Waller Street.

*c. Address: 251 Waller Street. City: San Francisco Zip: 94102

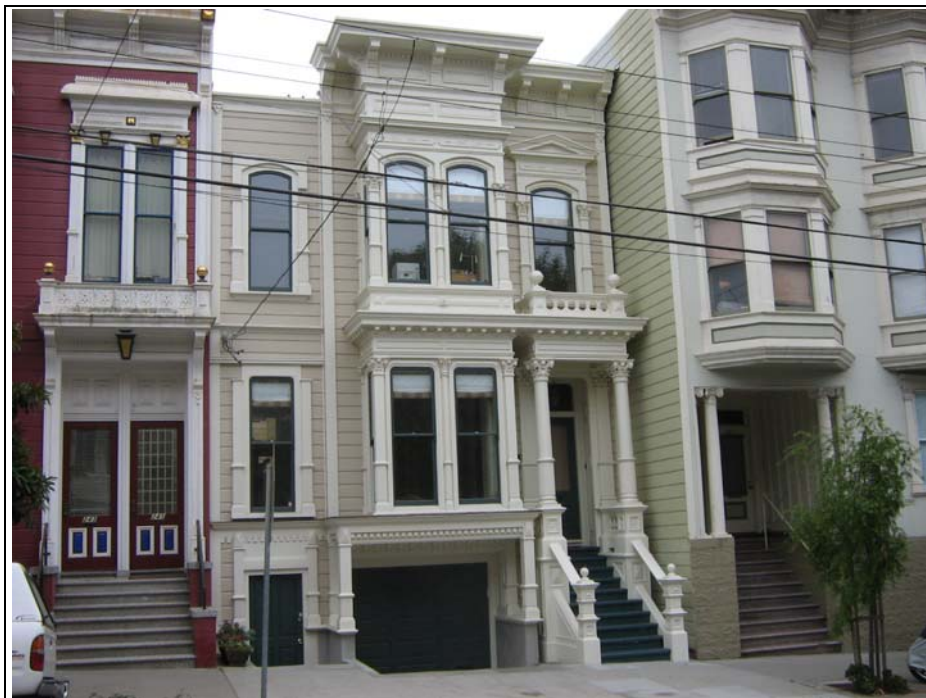
P5b. Photo: (view and date)

251 Waller Street is located on a 25' x 137' lot on the south side of Waller Street, between Buchanan and Webster Streets. Built ca. 1890, 251 Waller Street is a 3-story, wood frame, single family building designed in the Stick/Eastlake style. The rectangular shaped building is clad in wood drop siding and is capped by a flat roof. The primary façade faces north and is 3 bays wide. The ground story contains a below-grade garage and pedestrian door in the left bay. Both doors have pilaster surrounds and dentil cornices. In the right bay, wood steps lead to an entry portico with Corinthian columns, paneled frieze, and roof balustrade on the first story. The portico shelters a single recessed glazed, wood entry door with transom. The center bay of the first story contains a squared bay window with Corinthian pilasters and center colonnette and paneled frieze. The window and portico have a continuous modillion cornice. The left bay contains a flush window with pilaster surround, missing its capitals. The second story contains a flush window Corinthian pilaster surrounds and pedimented cap in the right bay. The center bay has squared bay window with similar decoration to the first-story bay window and arched sash. The left bay contains a flush window with pilaster surround, missing its capitals, and arched sash. All windows have undivided, wood, double hung sash. The façade terminates with a panel frieze and bracketed cornice on the center and right bays. The left bay has a modest cornice. The building appears to be in good condition and contributes to the Hayes Valley Residential Historic District (see DPR 523 D form).

View from north
8/29/2006
