PRIMARY RECORD

Page 1 of 1 *Resource name(s) or number (assigned by recorder) 2741 16TH ST

P1. Other Identifier Dalziel Plumbing Supplies

*c. Address: 2741 16th St City: San Francisco Zip: 94110

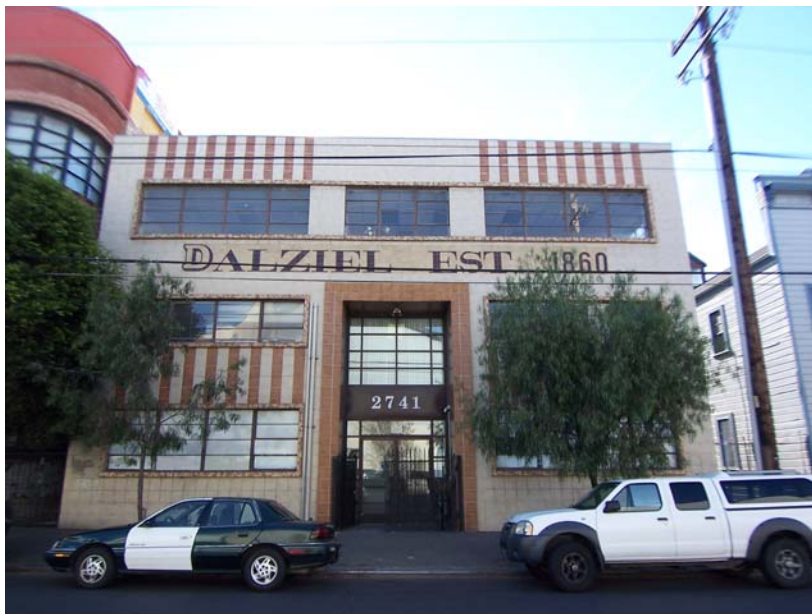
*P5b. Photo (view, date, accession #
100_5795.JPG, 11/21/2007,
view to S

2741 16th Street is a three-story, reinforced-concrete industrial building capped with a flat roof. The Late Moderne-style building occupies an irregularly shaped, 39,552 square-foot lot on the south side of 16th Street between Treat Avenue and Folsom Street. The ell-plan building, faced with tile at its primary facade, rests on a concrete foundation and is capped by a flat roof. The primary facade, which is 3 bays wide, faces north. The left and right bays of the first two floors are identical, with the second floor displaying a horizontal band of 2-light, awning windows over one fixed window and the first floor displaying a multi-light, fixed window. A spandrel panel divides the fenestration of the two floors. The middle bay of both floors features a recessed, double-height, gated entryway with paired, glazed, metal-sash doors with sidelights and a multi-light transom. Each bay of the third floor features a band of fixed and awning windows similar to those found at the other floors. Metal sashes and mosaic-tile surrounds characterize all fenestration. The primary facade terminates with metal coping. The building appears to be in good condition.
