PRIMARY RECORD

Resource Name or #: (Assigned by recorder) 856 CAPP ST

P1. Other Identifier: Iglesia del Pacto Evangelico

Eastern Neighborhoods Mission Survey

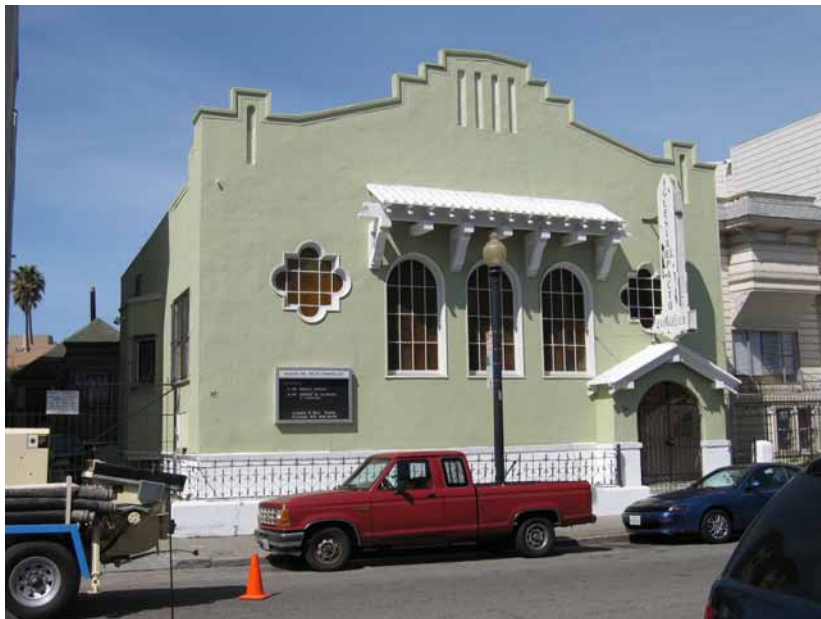
P5a. Photo

856 Capp Street is located on a 52' x 122.5' rectangular lot on the west side of Capp Street between 23rd and 24th Streets. Built ca. 1880, 856 Capp Street is a 1-story, wood frame former single-family dwelling that was converted into the Salem Swedish Baptist Church ca. 1915. By 1919, the building was expanded to fill the front yard set back. This expansion was likely the time when the building was stuccoed and remodeled to the Mission Revival style. The rectangular-plan building, clad in smooth stucco with a brick watertable, is capped by a gable roof. The foundation is not visible. The site features an ornamental case iron fence.

The building features 1 entrance, located at the north side of the primary façade, that includes a recessed door behind a metal security gate. The arched entryway is capped by a gable roof that is supported by simple square vigas and notched rafters and covered in Spanish clay tiles. A blade sign is located above the entry. Typical fenestration consists of fixed, arched, multi-light windows, flanked on either side by multi-foil oculus windows. (continued)

View of primary façade on Capp Street. 1/17/2008

A pent roof, supported by braces, simple square vigas and notched rafters and clad in clay tiles, is located above the center 3 windows. The primary façade terminates in a stepped parapet with blind niches.

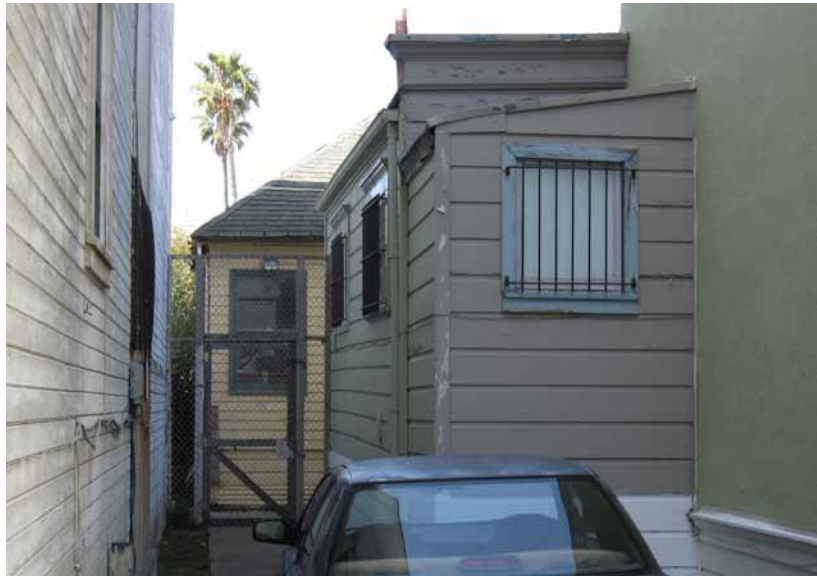
The secondary (south) and rear facades feature the original structure, without stucco covering. A detached single family residence is located behind the church, and is largely obscured from the street. It is clad with vinyl siding and capped with an asphalt shingled hip roof. This structure was added ca. 1915.

View of original (mauve) and detached single family residence (yellow) at the south side of building.
Source: San Francisco Planning Department
