State of California — The Resources Agency DEPARTMENT OF PARKS AND RECREATION PRIMARY RECORD		Primary # _____ HRI # _____ Trinomial _____
		NRHP Status Code _____
Other		
Listings _____		
Review Code _____		Reviewer _____ Date _____
Page 1 of 3	*Resource name(s) or number (assigned by recorder) 691 Market Street	
P1. Other Identifier:	Hearst Building, Examiner Building, 5 3rd Street	
*P2. Location:	<input type="checkbox"/> Not for Publication <input checked="" type="checkbox"/> Unrestricted	
*a. County:	San Francisco and (P2b and P2c or P2d. Attach a Location Map as necessary.	
*b. USGS 7.5' Quad:	San Francisco North	Date: 1994
*c. Address:	691 MARKET ST	City: San Francisco Zip: 94105

11.08.07	
*P10. Survey Type:		
Intensive: Transit Center District EIR		
*P11. Report Citation: (Cite survey report and other sources, or enter "none") None		
*Attachments: <input type="checkbox"/> None <input type="checkbox"/> Location Map <input type="checkbox"/> Sketch Map <input checked="" type="checkbox"/> Continuation Sheet <input checked="" type="checkbox"/> Building, Structure, and Object Record <input type="checkbox"/> Archaeological Record <input type="checkbox"/> District Record <input type

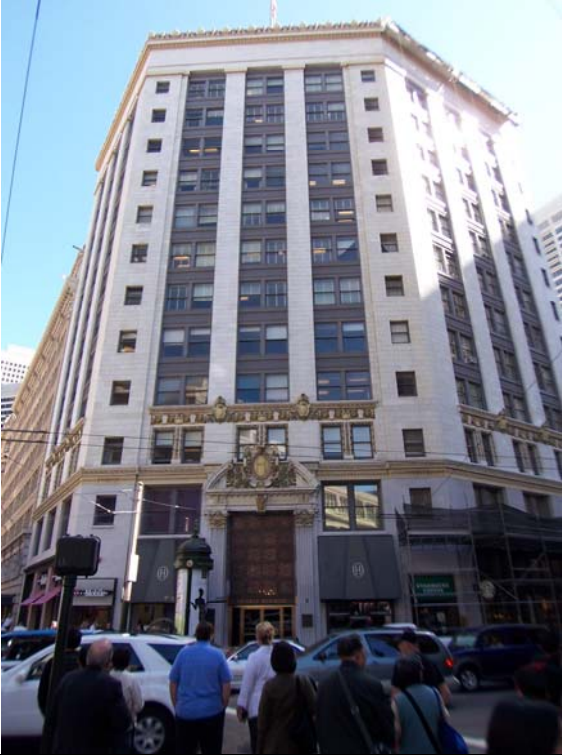
d. UTM: Zone: 10	mE/	mN (G.P.S.)
e.	Other Locational Data: Assessor's Parcel Number (Map, Block, Lot): Parcel #: 3707057	
*P3a. Description: (Describe resource and its major elements. Include design, materials, condition, alterations, size, setting, and boundaries.)		
<p>691 Market Street (or 5 3rd Street) occupies a five-sided 13,333 s.f. lot on the east corner of Market and 3rd streets. Designed by Kirby Petit & Green (interior by Julia Morgan), and built in 1909, the 13-story reinforced-concrete commercial building is clad in terra cotta. Its chamfered facade is organized in a two-part vertical composition. The two-story base has a monumental entrance on the angled elevation facing the corner of 3rd and Market streets. The entrance is surmounted by a massive broken pediment of terra cotta supported by fluted pilasters with Composite Corinthian capitals. A large cartouche with the letter "H" sits directly above the entrance. A polychrome terra cotta intermediate cornice divides the first and second floors. The transitional third story has another polychrome intermediate cornice. The shaft region is divided into three bays on each of the main elevations. Each bay contains two double hung wood windows and metal spandrel panels. Massive Tuscan piers demarcate the bays. The corner piers have one punched window opening at each floor. The facade terminates with a narrow terra cotta cornice surmounted by antefixes. The building is topped by a flat roof. The building appears to be in good condition.</p>

P5b. Photo: (view and date)	
	View to SE; 9/26/07; 100_4457.JPG	
	*P6. Date Constructed/Age and Sources: <input checked="" type="checkbox"/> Historic <input type="checkbox"/> Prehistoric <input type="checkbox"/> Both	
	1909; Assessor's office	
	*P7. Owner and Address:	
	The Hearst Corp. 5 3rd St. Ste. 200 San Francisco, CA 94103	
	*P8. Recorded by	
	Tim Kelley Kelley & VerPlanck 2912 Diamond Street #330 San Francisco, CA 94131	
	*P9. Date Recorded:

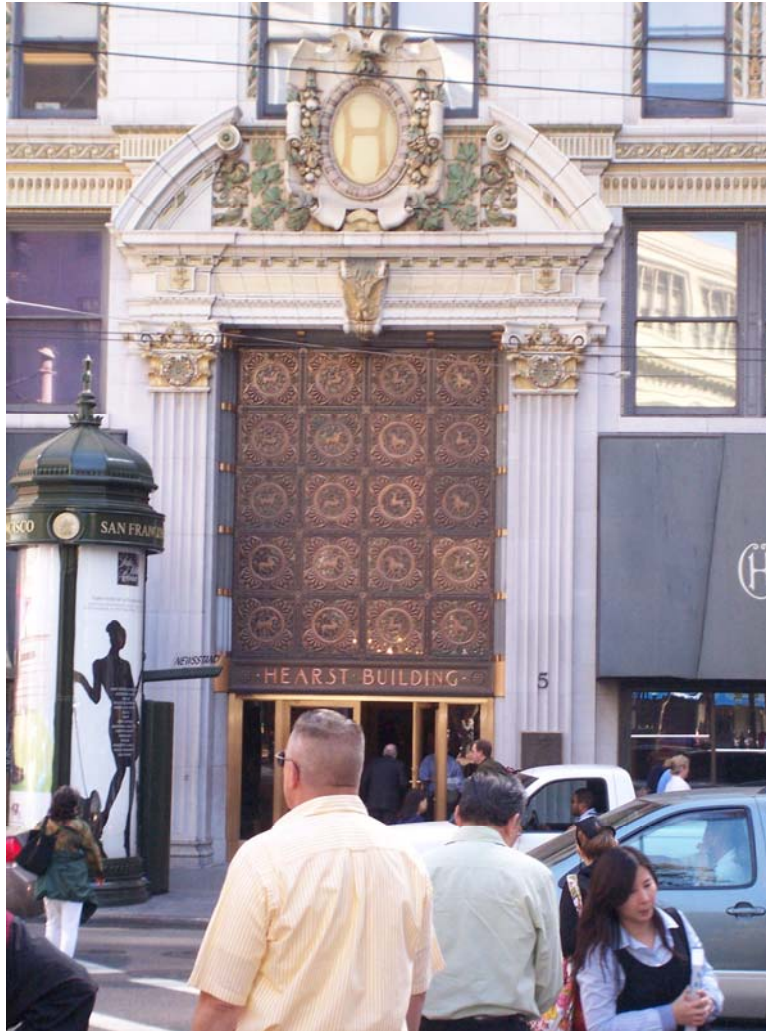
Main Entrance, 100_4459, 9.26.07
